10.1302/2633-1462.58.BJO-2024-0029.R1

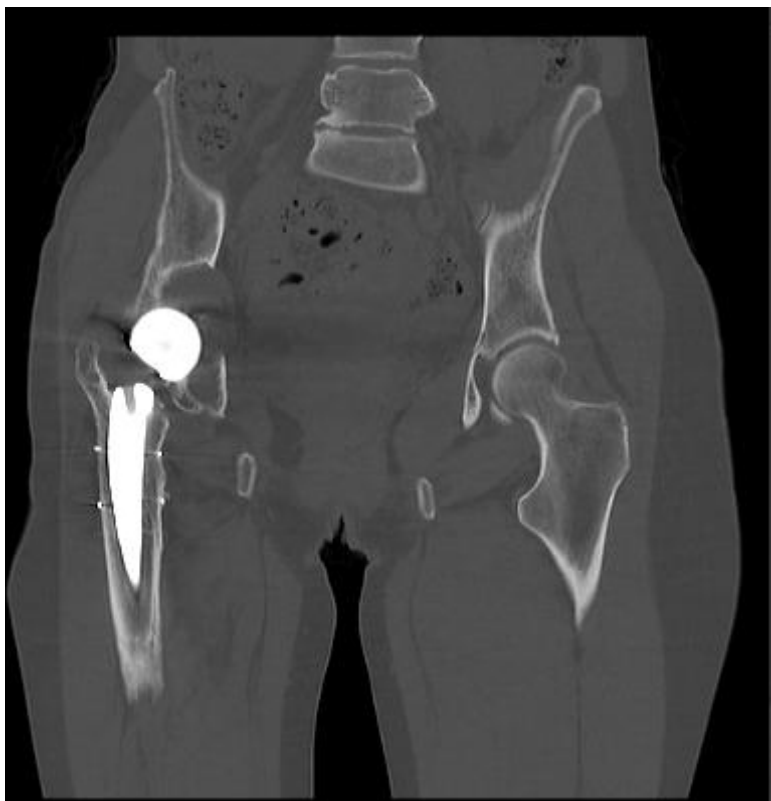
Fig b. Example case 3: CT scan showing a massive osteolysis due to extensive polyethylene wear.

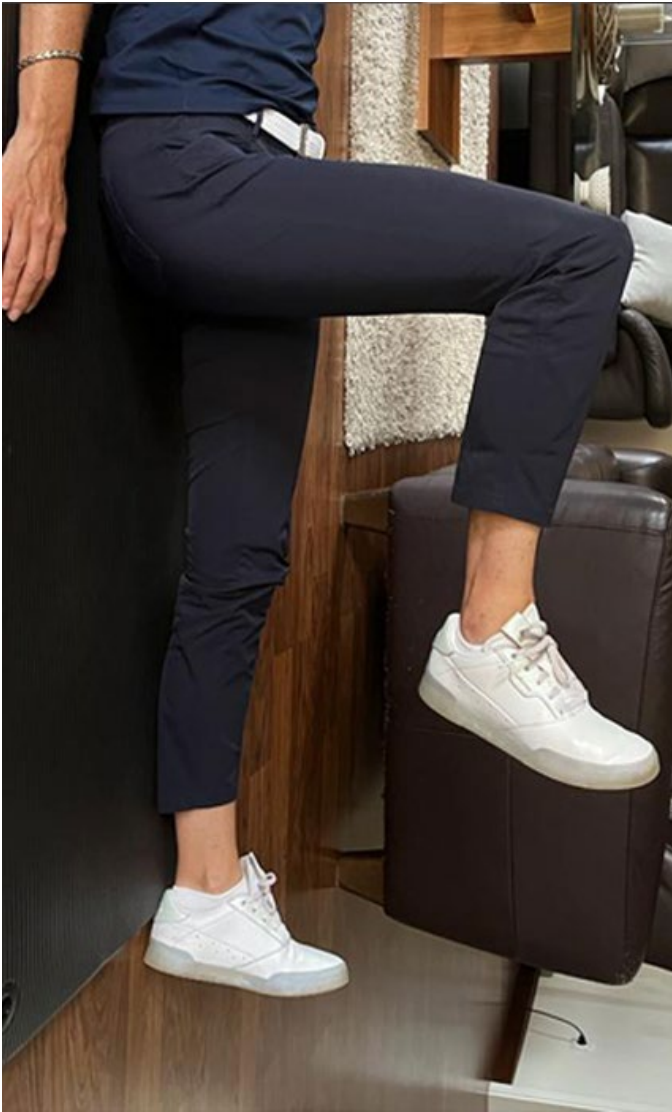
Fig d. Example case 3: clinical outcome at three-year follow-up.
